## ABSTRACT

In the field of high altitude ballooning the use of a zero pressure balloon has become common for its ability to stay at altitude longer than traditional latex weather balloons. This opens the doors for a new variety of high altitude experiments; however these balloons can often present challenges when it comes to flight control and termination. For environment and safety reasons it is ideal to bring the balloon and payload system down together. The purpose of this project is to create a reliable form of termination for zero pressure balloons with the long term goal of being able to accurately control the balloon descent rate. While many companies already use a similar system, this valve grants amateur ballooning groups a more accessible way of flying zero pressure balloons.

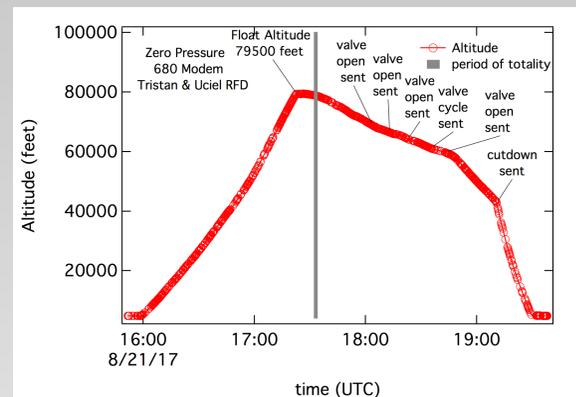
A graph of the altitude over time is depicted in Figure 4 for the eclipse zero pressure balloon. During totality the balloon dropped altitude as expected due to the decrease in temperature. However after totality the balloon continued to descend at a constant rate. In between float altitude and the descent rate change that occurred at about 1:40 PM the open valve command was sent three times. After cycling the valve and resending open valve command the descent rate changed. At about 40,000 feet the balloon was separated from the payload chain via the cutdown termination system.

Figure 4: Altitude changes during eclipse flight including totality period and sent commands.

Comparing Figure 4 to past zero pressure balloon flight data showed that trends for ascent rate and maximum altitude were similar. Therefore despite the issues seen in the valve system there was no apparent leak rate that could be seen during ascent.

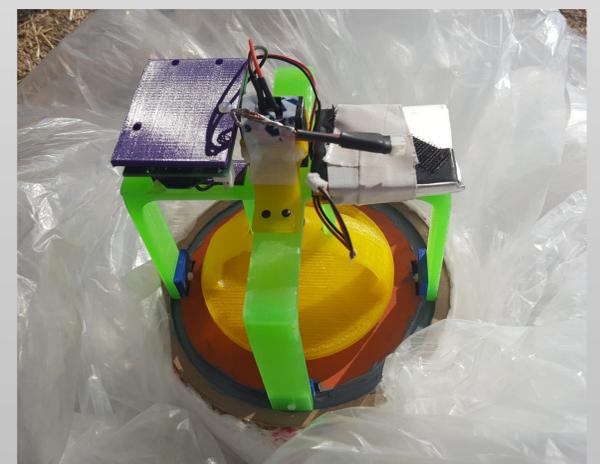
The placement of a SPOT tracking system into the balloon fill arm allowed our team to recover the valve and zero pressure balloon. Upon retrieval of the valve it was discovered that it had only opened partially. It was concluded that the valve didn't open until after sending the cycle command, which is designed to open and close the valve repeatedly. From the command timeline of the eclipse flight it was determined that the cause for the valve not opening fully is that something was restricting its movement. The most likely reason for this would be that the cold temperatures created too much friction in the threaded rod. However it is also possible that the different materials and corresponding coefficients of thermal expansion interfacing in the lid resulted in the inability to open the valve.

Results of the eclipse flight show that the valve has room for improvement. The next step in this project will be attempting to recreate the failures that occurred during the eclipse flight. Theories as for why the valve didn't fully open question the low temperature effects on both the plastic elements and threaded rod.

Figure 5: Completed valve recovered from eclipse flight

Future alterations to the valve include the addition of a limit switch to ensure that the lid will open to its full height. Along with this all printed parts will be the same material to avoid different thermal expansion or contractions occurring during flight. This change is particularly important for the lid interface.
