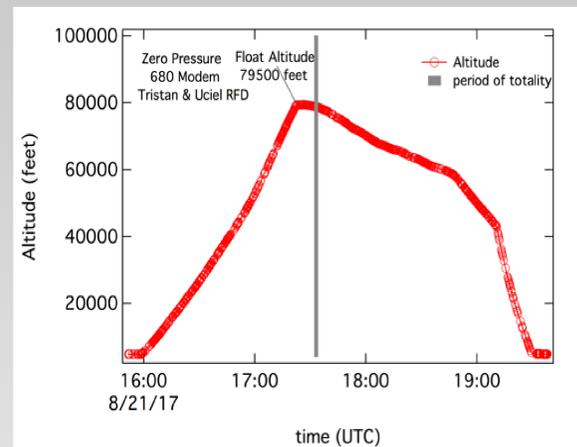
A graph of the altitude over time is depicted in Figure 4 for the eclipse zero pressure balloon. During totality the balloon dropped altitude as expected due to the decrease in temperature. However after totality the balloon continued to descend at a constant rate. In between float altitude and the descent rate change that occurred at about 1:40 PM the open valve command was sent three times. After cycling the valve and resending open valve command the descent rate changed. At about 40,000 feet the balloon was separated from the payload chain via the cutdown termination system.

Figure 4: Altitude changes during eclipse flight including totality period and sent commands.

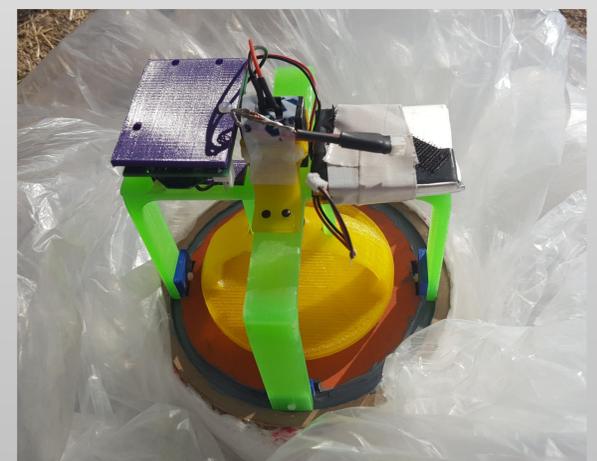
The placement of a SPOT tracking system into the balloon fill arm allowed our team to recover the valve and zero pressure balloon. Upon retrieval of the valve it was discovered that it had only opened partially.

It was concluded that the valve didn't open until after sending the cycle command, which is designed to open and close the valve repeatedly. From the command timeline of the eclipse flight it was determined that the cause for the valve not opening fully is that something was restricting its movement. The most likely reason for this would be that the cold temperatures created too much friction in the threaded rod. However it is also possible that the different materials and corresponding coefficients of thermal expansion interfacing in the lid resulted in the inability to open the valve.

Figure 5: Completed valve recovered from eclipse flight

Future alterations to the valve include the addition of a limit switch to ensure that the lid will open to its full height. Along with this all printed parts will be the same material to avoid different thermal expansion or contractions occurring during flight. This change is particularly important for the lid interface.
