## ABSTRACT

In the field of high altitude ballooning the use of a zero pressure balloon has become common for its ability to stay at altitude longer than traditional latex weather balloons. This opens the doors for a new variety of high altitude experiments; however these balloons can often present challenges when it comes to flight control and termination. For environment and safety reasons it is ideal to bring the balloon and payload system down together. The purpose of this project is to create a reliable form of termination for zero pressure balloons with the long term goal of being able to accurately control the balloon descent rate. While many companies already use a similar system, this valve grants amateur ballooning groups a more accessible way of flying zero pressure balloons.

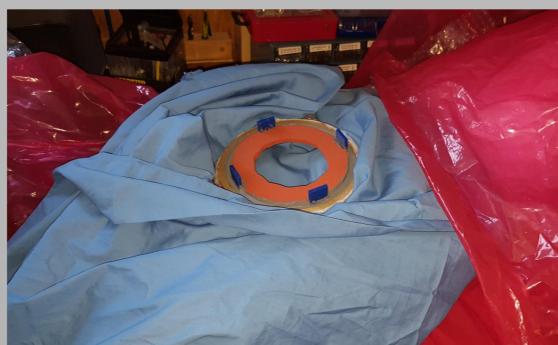
In order to interface the valve into the apex a special zero pressure balloon was crafted by Raven Industries that includes a ring in the apex. Besides electronics and elastomer seal, all valve parts were 3D printed using ABS and PLA plastics. The circular base as seen in Figure 1 was individually sealed into the apex while being cautious of damaging the balloon envelope. An ATV sealant was used for its ability to withstand cold temperatures.

Figure 1: Sealing valve base into the balloon apex

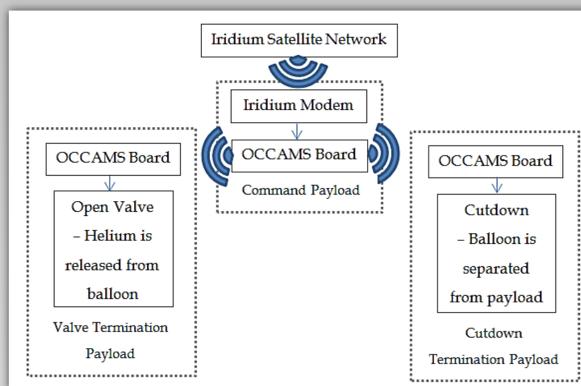
The valve utilizes the same OCCAMS board previously used between MSGC cutdown and tracking systems. In order to maintain two unique forms of termination as per FAA regulations the valve needed to be flown alongside a cutdown device and the XBEE radios programed as a meshed network. Commands are sent through the Iridium satellite constellation and then can be communicated through the OCCAMS boards to either the valve or cutdown systems.

Figure 2: Communications between command payload and termination systems

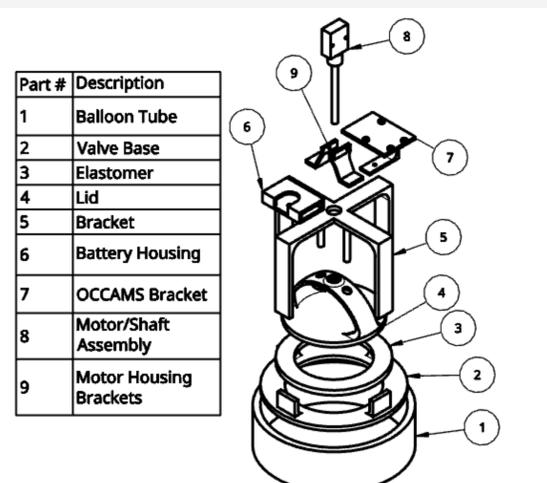
After much consideration the chosen design for the valve utilizes a threaded rod attached to the DC motor as seen in the exploded view in Figure 3. The rod is threaded through the top of the lid and two 3D printed pegs prevent the lid from rotting when the motor is powered. The mechanical advantage provided by the shaft was enough to keep the lid sealed throughout flight. In order to promote the best possible radio communications the OCCAMS board is mounted with the XBEE facing the command payload. An additional feature that was added was an extra battery connected to a group of resistors to keep the motor warm.

Figure 3: Exploded view of basic valve system.
